Analyses of Contaminated Solar Array Handrail Samples Retrieved from Mir

Prepared for the
34th Intersociety Energy Conversion Engineering Conference
sponsored by the Society of Automotive Engineers
Vancouver, British Columbia, Canada, August 1–5, 1999

9. SPONSORING/MONITORING AGENCY NAME(S) AND ADDRESS(ES) National Aeronautics and Space Administration Washington, DC 20546-0001			10. SPONSORING/MONITORING AGENCY REPORT NUMBER NASA TM-1999-209399

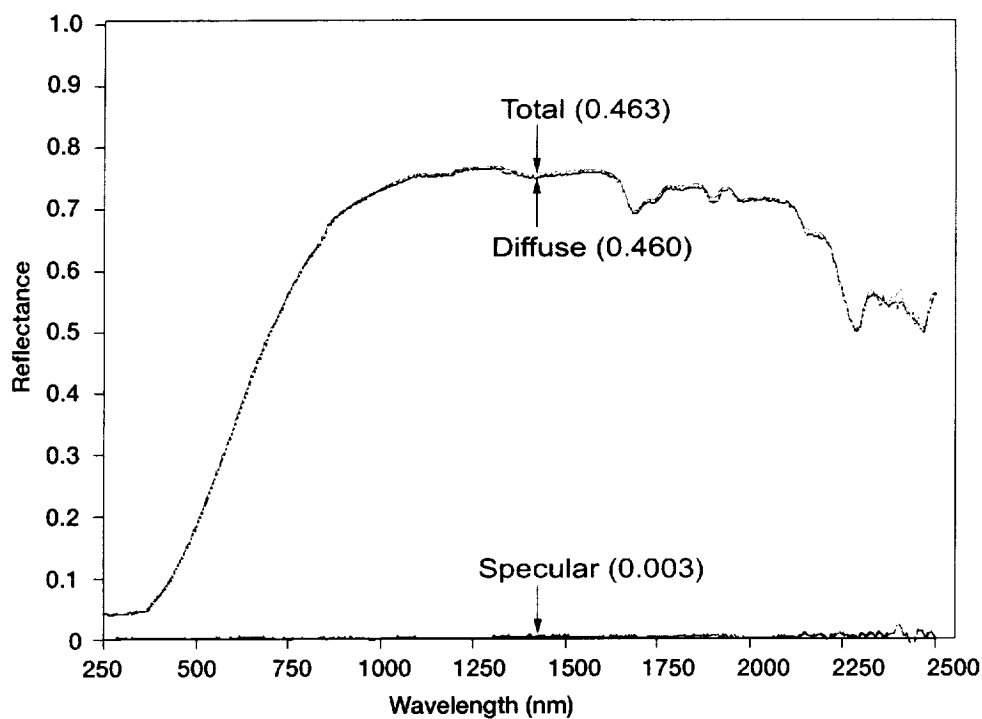
The results of optical property characterization are provided in table I. The surface browning has increased the solar absorptance of both types of handrail samples significantly. The solar absorptance of unexposed AK-573 is 0.294 (ref. 1). The solar absorptance of the darkened handrail paint was 0.537 to 0.555, an increase of 0.243 to 0.261. The spectral reflectance of the solar array facing side of the handrail sample is shown in figure 7. The flexible handrail over-wrap fabric had an increase in absorptance of 0.14 in the exposed area compared to the unexposed area. The total reflectance spectral data for the exposed and unexposed areas are shown together in figure 8.

Figure 7. Spectral reflectance for the solar array facing side (side A) of the rigid handrail sample.

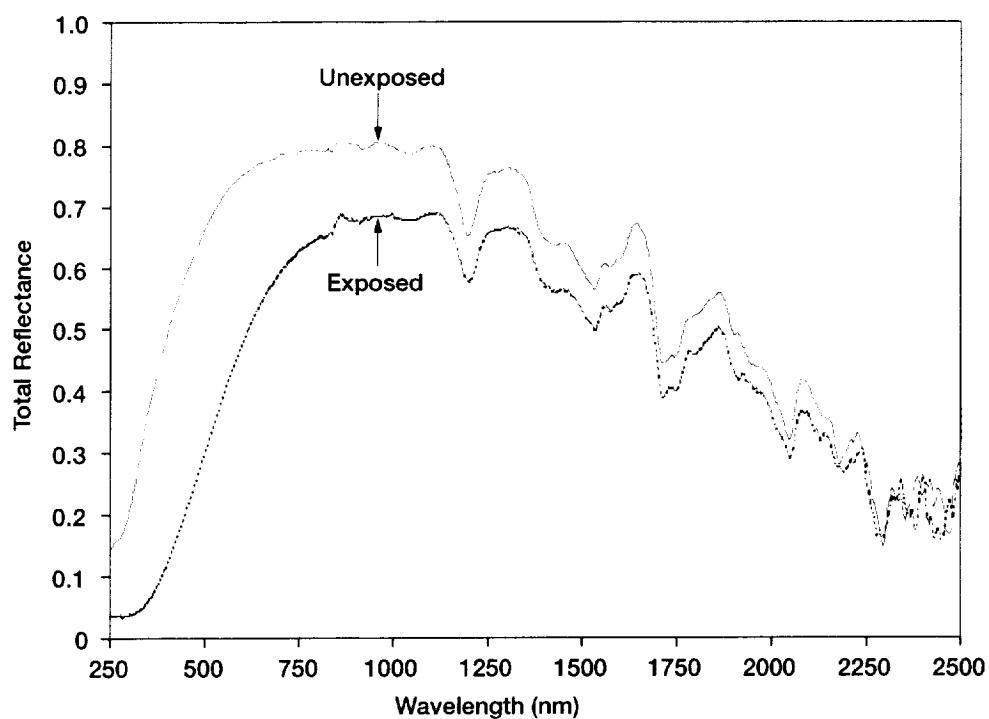
Figure 8. Total reflectance for unexposed ($\alpha_s=0.330$) and exposed ($\alpha_s=0.465$) areas of the flexible handheld tape over-wrap fabric.

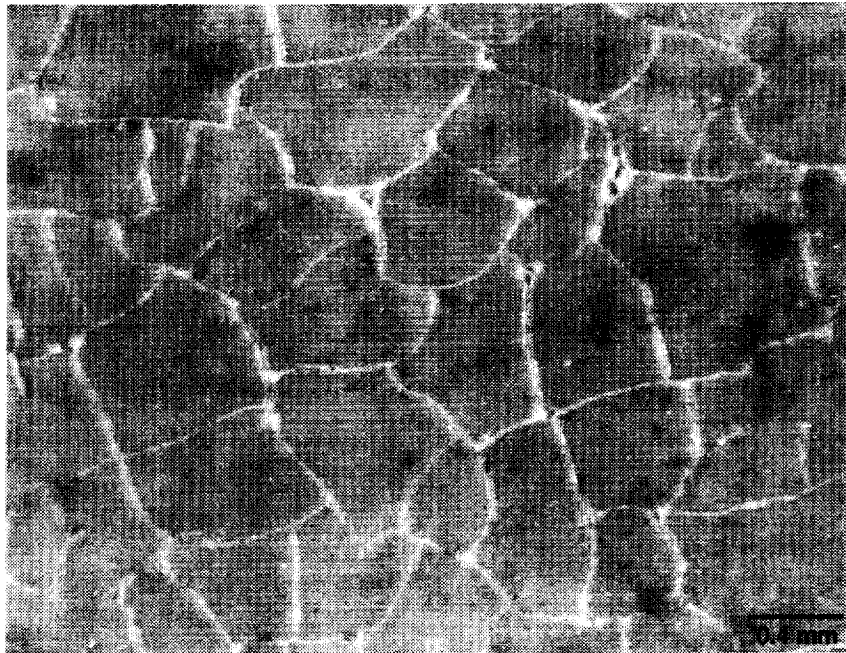
Rigid Handrail Sample (Flat Section). The uniformly dark brown side (array facing side) of the flat handrail sample had a rainbow hue and was clearly crazed, as can be seen in figure 9. Although the space-facing side of the handrail was also brown, its surface did not have a rainbow hue and was not crazed, as can be seen in figure 10. Surface "holes" were observed on the space-facing side (see fig. 10). These holes are believed to be the result of air pockets produced during the painting process. After close examination, these holes appear present on the array facing side, faintly visible underneath the thick contaminant layer.

Figure 9. Side A (array-facing side) of the rigid handrail showing crazing of the brown contaminant layer.

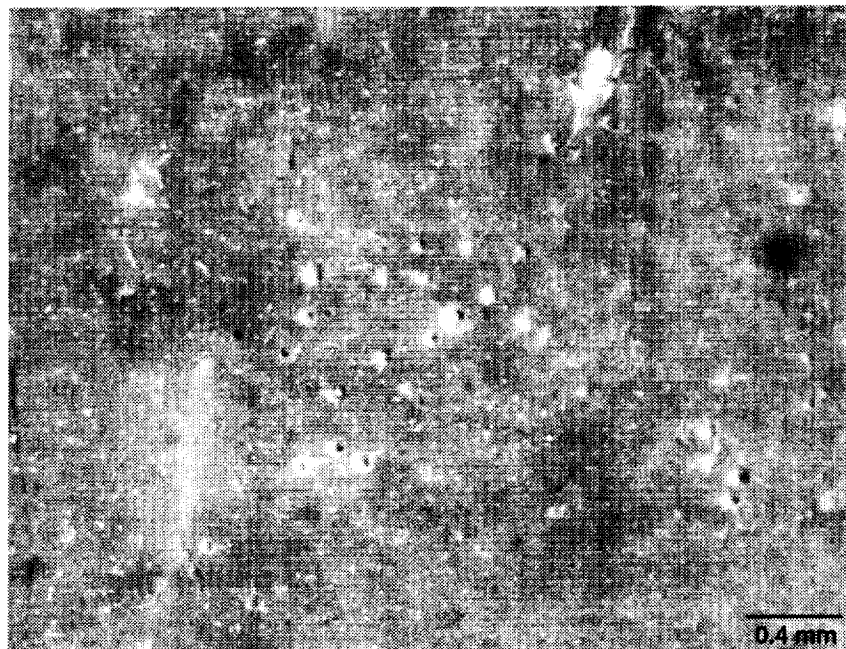
Figure 10. Side B (space-facing side) of the rigid handrail. The brown contaminant layer is not crazed on this surface.

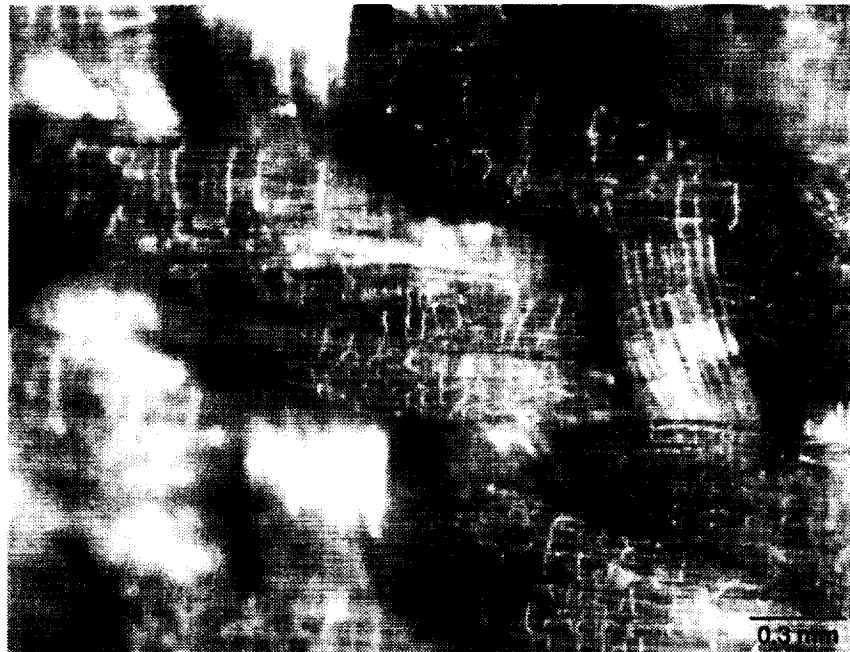
Flexible Handhold Over-Wrap Tape. Optical microscopy examination of the exposed, brown region of the handhold tape fabric revealed micro-crazing of a contamination layer, as shown in figure 11. This crazed layer is not present on the protected, unexposed region that has an off-white color (see fig. 12).

Figure 11. Micro-crazing of the brown contaminant layer on the exposed area of the flexible handhold over-wrap tape fabric.

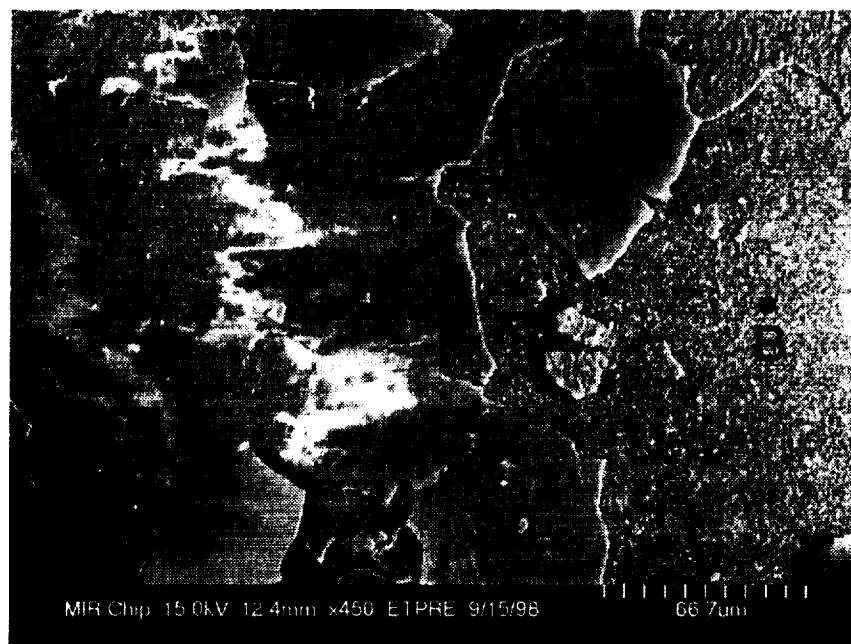
An image of the brown contaminated surface of the paint chip is shown in figure 15. There appears to be a contaminant layer that is crazed and has spalled off the surface in areas. EDS point spectra were taken on a flaked-off contaminant piece (point A) and on an area where the contaminant layer appears to be missing (point B), as shown in figures 16 and 17, respectively. The contaminant layer is composed primarily of oxidized silicon (from silicone contamination). These results are consistent with electron spectroscopy for chemical analysis (ESCA) measurements reported by Visentine, et al. (ref. 1). Point B is composed of C, O, Zn and Ti, with small amounts of Si, Al and an unknown element, possibly Pb. The oxidized silicon layer has spalled off the surface in this region, and the surface has a strong C and O presence.

Figure 15. Brown stained area on the surface of the rigid handrail sample. The contaminant layer is crazed and has lifted up, or spalled off, in certain areas.

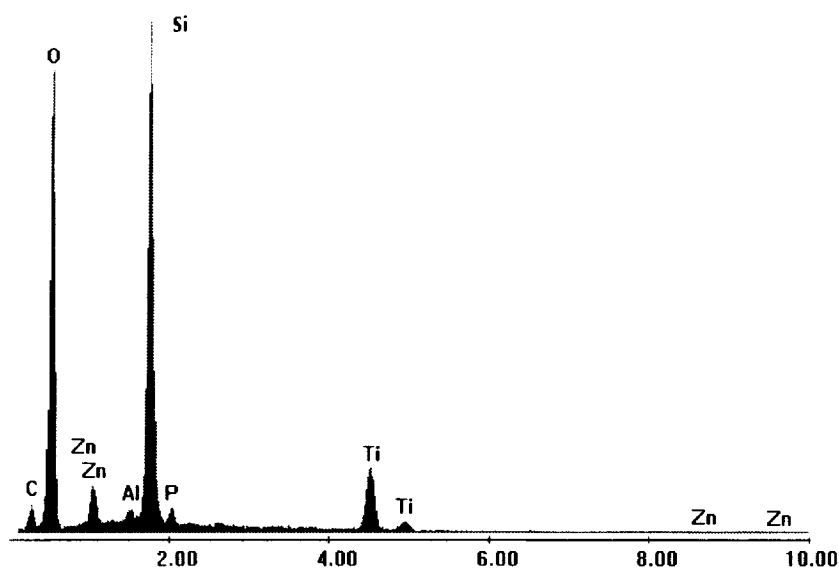
Figure 16. EDS spectra taken at point A in Figure 15. Spectra shows the presence of oxidized silicone contamination.

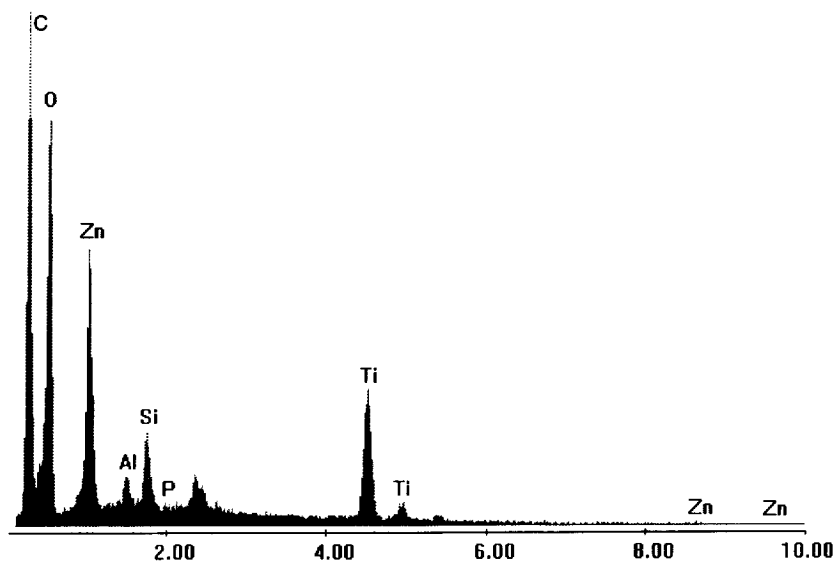
Figure 17. EDS spectra taken at point B in Figure 15. Spectra similar to the cross-sectioned area, but with much larger C and O peaks.

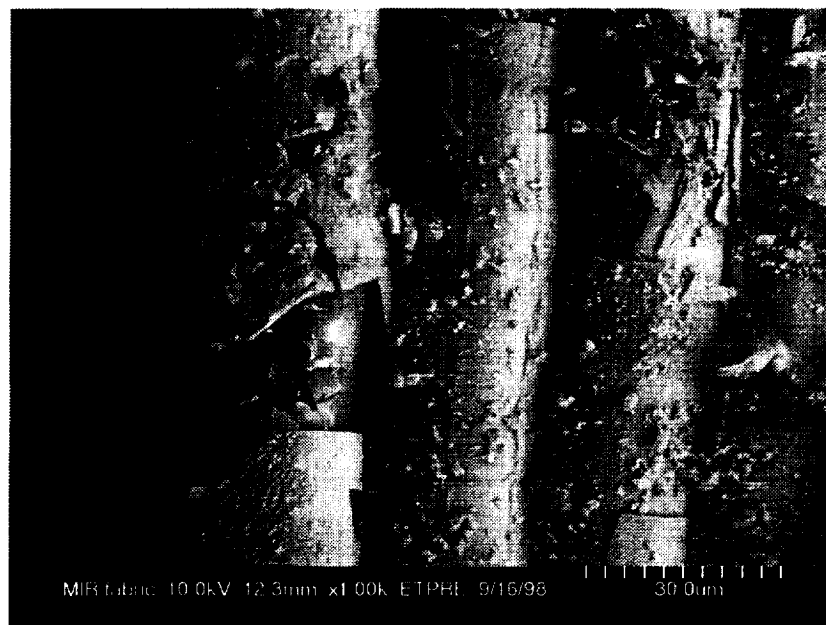
The exposed brown stained area of the fabric was imaged and revealed a very thick layer of contaminant that has spalled off in some areas (possibly due to post-retrieval handling), as shown in figure 20. A near cross-section of the contaminant layer is seen in this image (to the right of point A), and at higher magnification the thickness was measured to be ~1.6 µm thick. EDS point spectra were obtained at two locations in figure 20, one at an area where the contaminant has spalled-off (point A), and the second on top of the thick contaminant layer (point B). The corre-

Figure 20. Brown exposed region of the flexible handhold fabric showing the presence of a very thick contaminant layer that has crazed and spalled off in certain areas.

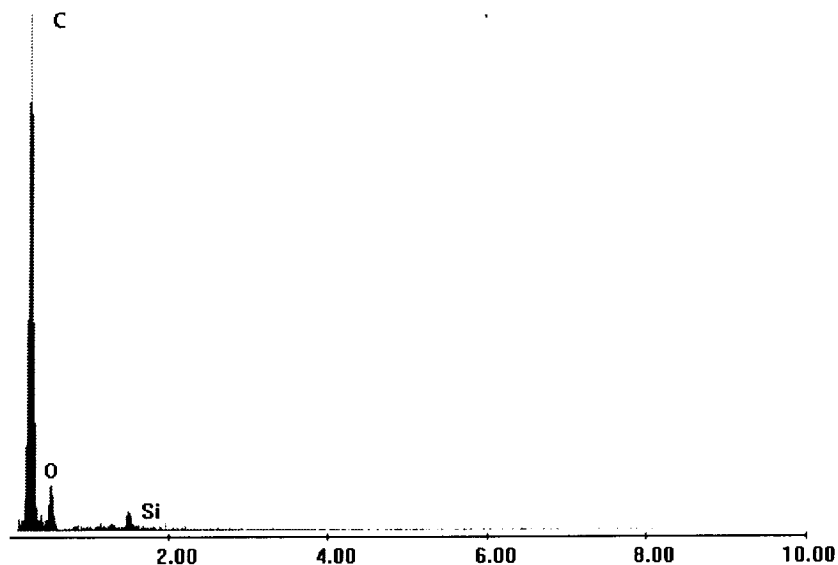
sponding spectra for points A and B are shown in figures 21 and 22, respectively. Point A, where the contaminant has spalled off looks primarily like the unexposed fibers, mostly C with some O. A very small Si peak is present. Point B, focused on the contaminant film, is Si and O, with almost no C present. The thick contaminant layer is clearly oxidized silicon, similar to the contaminant layer on the rigid handrail.

Figure 21. EDS spectra taken at point A in Figure 20.

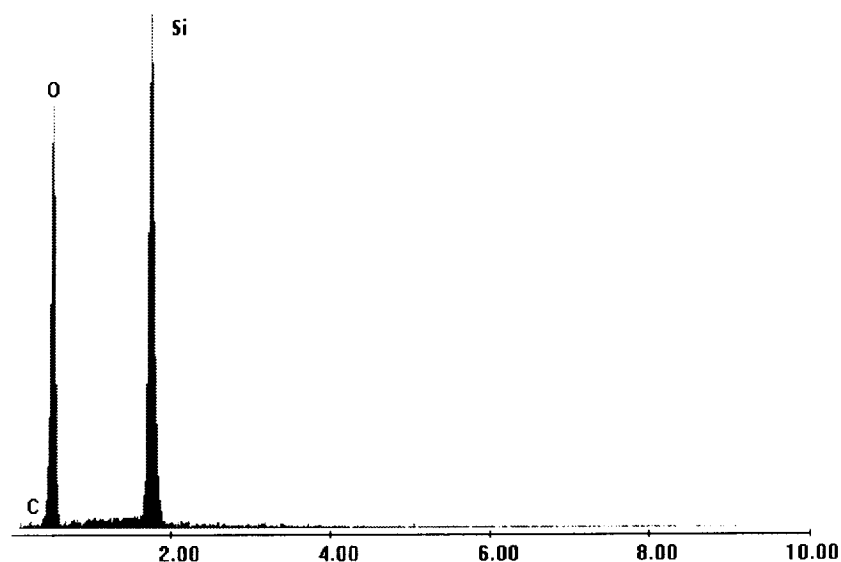
Figure 22. EDS spectra taken at point B in Figure 20. Spectra shows that the contaminant layer is oxidized silicon.

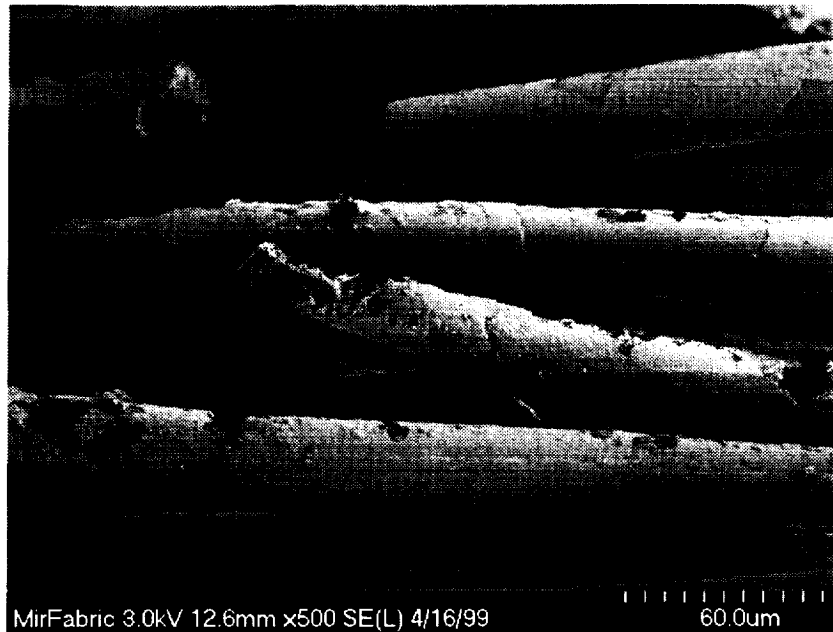
Figure 23 shows an area where the contaminant layer has spalled off the fibers in various locations while in space, and atomic oxygen has eroded the organic fibers. Several sections of fibers have been completely eroded away. This shows that the contaminant layer, which is resistant to atomic oxygen erosion, has become so thick that it became a source of particulate contamination in space.

Figure 23. FESEM image of the contaminated flexible handheld tape fabric fibers. Atomic oxygen erosion has occurred in-space at locations where the contaminant layer has spalled off.

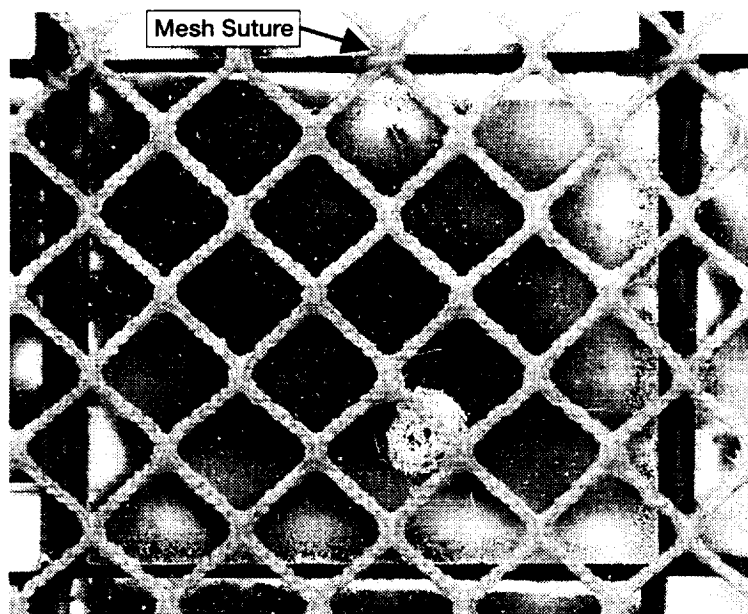
Figure 24. Backside of Mir solar cell (16-6) with mesh backing in place. Contaminant shadow lines (shaded by particulate pieces) point back towards the mesh suture at the top center of the cell (ref 7).

As previously mentioned, the entire array was coated with contaminant films. The cover slides and the optical solar reflectors (OSR) on the backside of the arrays were covered with a nonuniform diffusely reflecting film (refs. 1 and 6). Figure 24 is a photograph of the backside of a solar cell (cell 16-6), and shows a structural mesh backing which was present over the OSR. The matte contaminant layer is clearly visible and appears to be thicker on the edges of the cell. The solar cells (front and back sides) were found to be contaminated by an organic silicone film which was converted to a silica coating by atomic oxygen exposure (refs. 1 and 6). Silicone compounds used to laminate the solar array panel are believed to be the source of contamination on the panels. For example, the source of the silicone contamination on the front and back of the cells visually appears to have evolved where reinforcement threads penetrated silicone potting strips between the cells (ref. 1). This can be seen in figure 24 by examining the suture thread holding the mesh backing in place at the top of the cell. Line-of-site contaminant shadows point towards the suture.

Based on these solar cell findings, and the fact that the handrail section facing the array appeared to be more contaminated than the space facing side, the source of contamination on the handrail samples appears to be primarily from silicones in the arrays themselves.
